## **Test results**

**Carrying Capacity of Suction Cups  
Euro-Tech  
(similar to 388 and 540 from Pannkoke)**

**An investigation by the Fachhochschule Kiel  
(executed in the first half year 2001)**

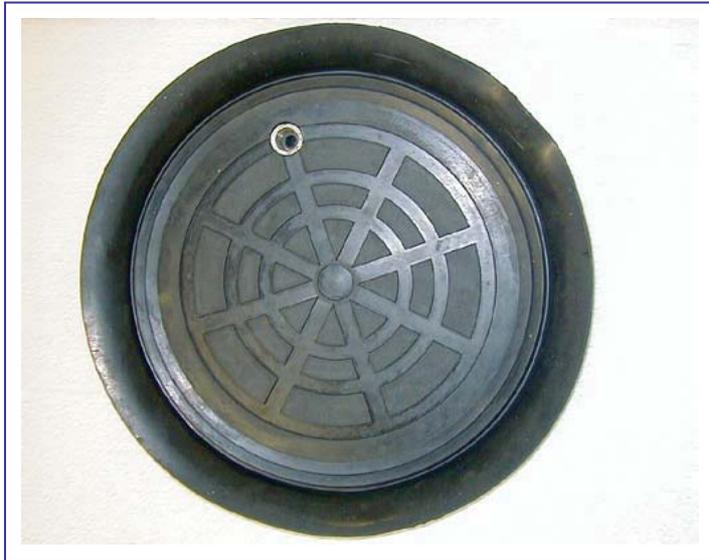
**Picture 3:** Suction cup Euro-Tech 388 fails after dynamic load. The metallic strap retainer is torn via the vacuum under the suction cup.

At further increase of the tensile force the suction cup rubber released from the aluminium base plate (failure picture similar to picture 3).

At a force of 4128 N the suction cup rubber stays on the glass plate and the metal ring which holds the rubber on the suction cup base plate deforms itself. Afterwards the suction cup rubber releases from the base plate, the suction cup breaks and the rubber tears off from the glass plate. In picture 3 the damage situation is shown.

From that we get the conclusion that this suction cup has a high failure potential due to the mechanically low overload-proof rubber metal connection at force peaks. Such force peaks can arise by swinging of the load or by lifting processes, especially at hydraulic forces.

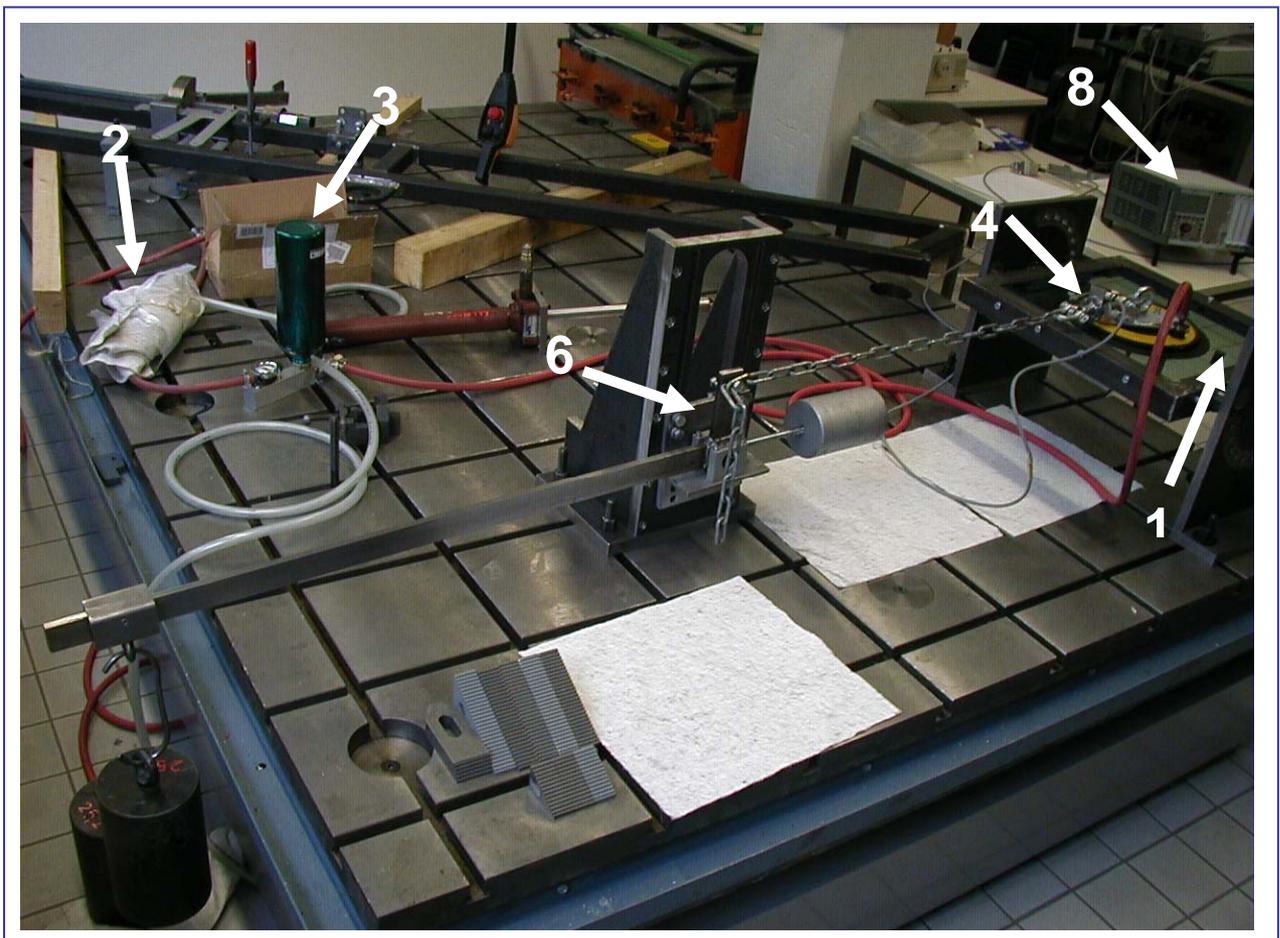
Picture 1: The suction cups are placed on a clean glass plate (1) and connected to 0.6 bar partial vacuum. A Venturi jet with noise insulation coat (2) as well as a vacuum tank (3) provides the vacuum system.

On the suction cup is exerted via the weight loaded lever (6) a statical force via the load cell (4) (type: HBM U2B 10 kN) (6), which is taken over at the measuring bridge (8) (type: HBM MGC55-AB1).

**Picture 1:** Experiment set-up for testing of vacuum suction cups at quasi-statical load.

The suction cups are pulled parallel to the glass plate which corresponds to the vertical lifting of glass panes.

In a first trial the suction cups are loaded quasi-static with a constant force and the tensile force and the slipping movements are measured. The force is then increased in steps if there is no slipping movement to be noted within 5 minutes. The suction cups are lifted after each load increase and again set to the glass plate and impinged with vacuum.

In a second trial section the suction cups are dynamically loaded till the tear off and the maximum force is registered at the measuring bridge by the "Peak-Hold-display".
